WAITSFIELD VILLAGE (BIG EDDY) COVERED BRIDGE

REHABILITATION PROJECT

## BRIDGE INVESTIGATION AND RECOMMENDATIONS REPORT (FINAL)

**AUGUST, 2011**

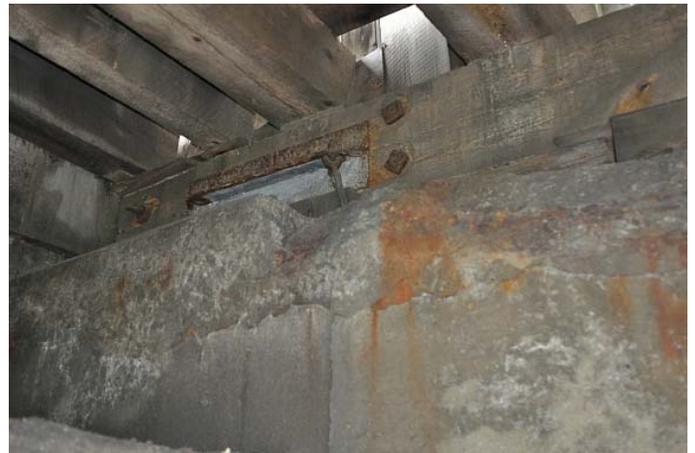
The existing abutments exhibit a number of problems, including a significant void at the base of the north abutment, areas of severe spalling, and minor surface cracking.

The concrete sections have areas of severe spalling and voids. These areas should be repaired. All loose material should be removed and concrete patching performed in the areas of spalling. There is a sizeable void located near the base of the north abutment at the normal water line of the Mad River. Also, the bridge seat where the upstream truss rests on the north abutment is experiencing advanced deterioration. These areas, and any other areas of spalling or deterioration should be repaired.

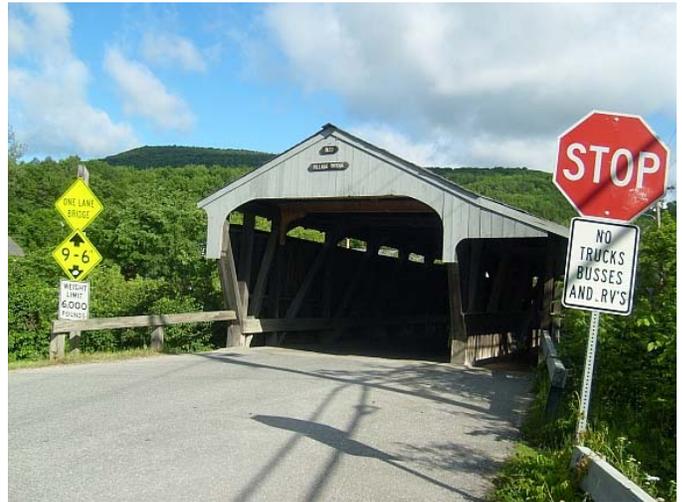
There are a number of signs on the roadway approaches to the bridge that detract from the look and character of the bridge. Also, the signs are not plumb. Consideration has been given to reducing the signs and straightening the posts should the signs remain.

The “NO TRUCKS BUSSES AND RV’S” sign and the “WEIGHT LIMIT 6000 POUNDS” are redundant. We recommend the elimination of the “NO TRUCKS BUSSES AND RV’S” sign, and recommend that the “WEIGHT LIMIT 6000 POUNDS” sign be moved so it is mounted below the “STOP” sign. We also recommend that the signs be supported on square steel tube posts and set plumb, and that any signs that do not have the current reflectivity coating be upgraded to be compliant with the latest Manual on Uniform Traffic Control Devices (MUTCD).

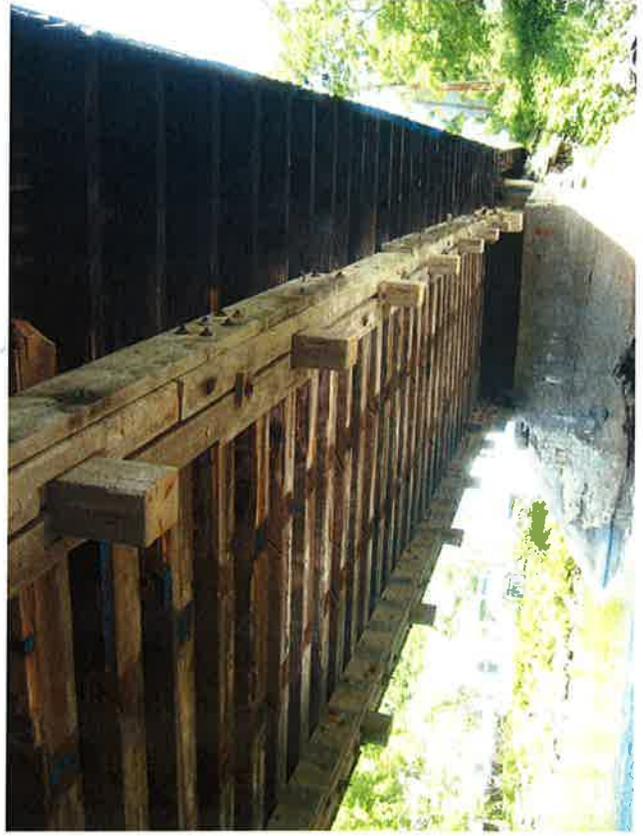
- Cantilevered edge of sidewalk (downstream) showing signs of downward deflection
- Sidewalk deck planks in fair to good condition with some minor rot and excessive wear

Cantilevered support of the sidewalk

Based on the foregoing information, our recommendation is to add a new steel truss configuration, self-supporting sidewalk to replace the existing cantilevered sidewalk. This option has the most modest impact to the existing bridge, and a reasonable cost. This option will eliminate the sidewalk loading on the existing downstream truss, which will be beneficial to the bridge as it continues to age.

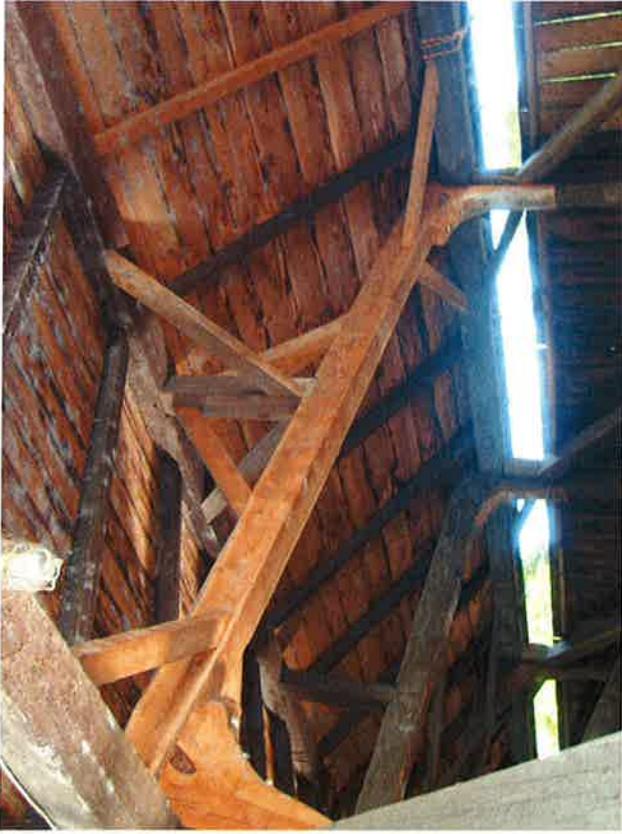
- Cedar shingle roofing in good condition, with no leaks observed
- Timber roof rafters in good condition, with the exception that six (6) rafters are split, rotted, or broken

Roof rafters

There are several structural members that are in need of repair or replacement. These members are split, cracked or showing signs of rot. These include five floor beams, five sidewalk rafters, one cross beam, and one roof rafter. We recommend that these elements be entirely replaced with new elements that match the existing members or be fitted with “sister” beams (doubled with new beams).

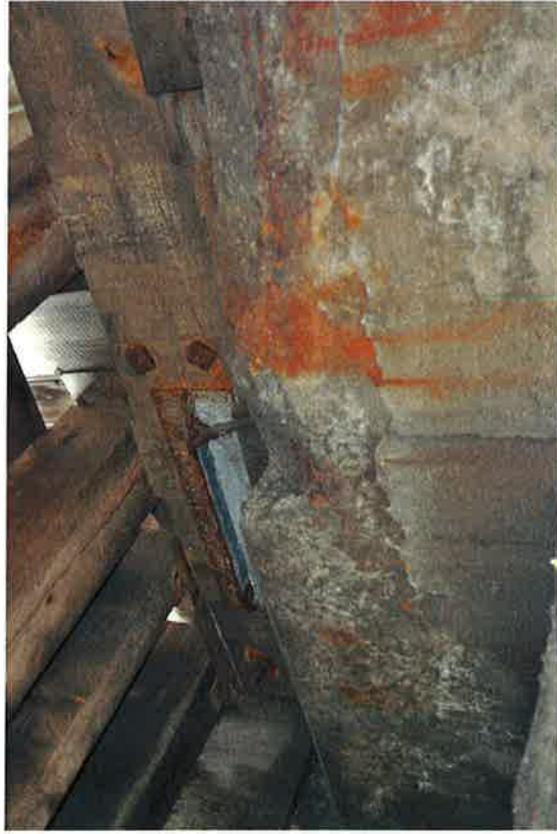
Spalling concrete at south abutment – west side

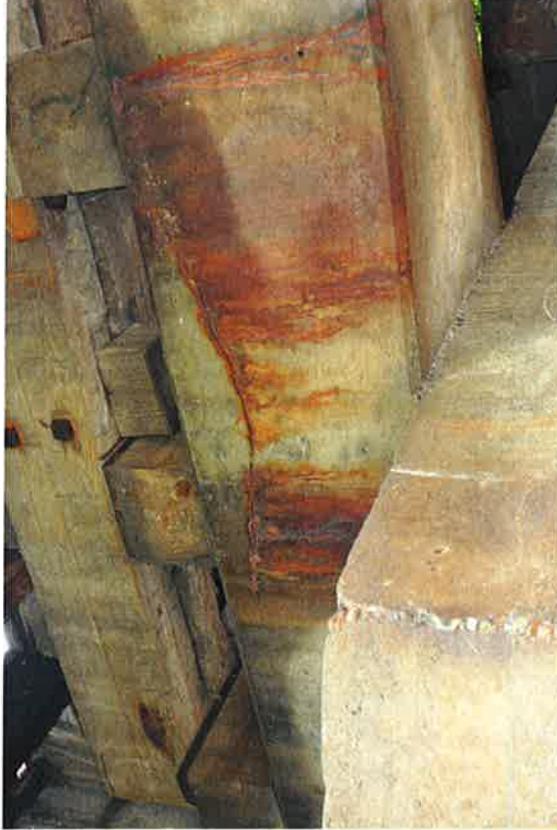
Spalling concrete at south abutment – east side

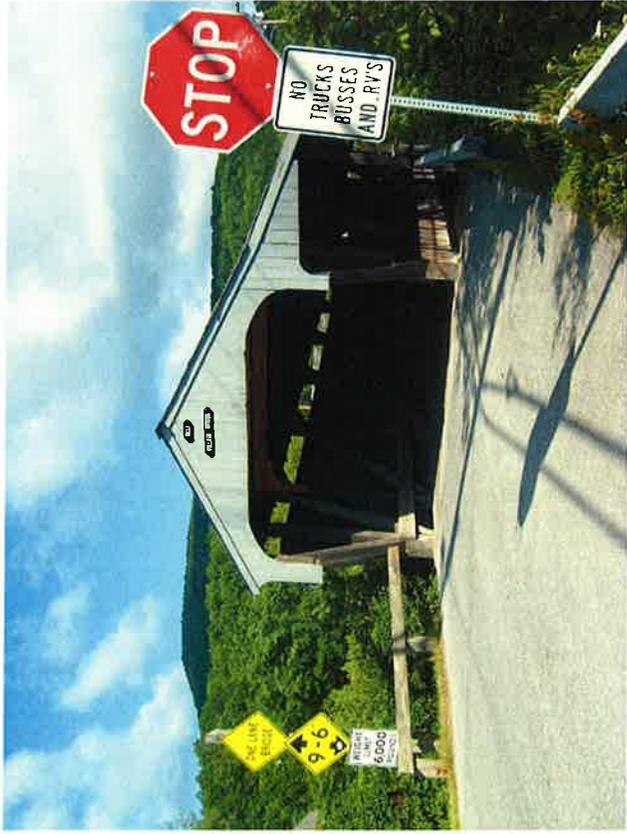
Signing on the south approach

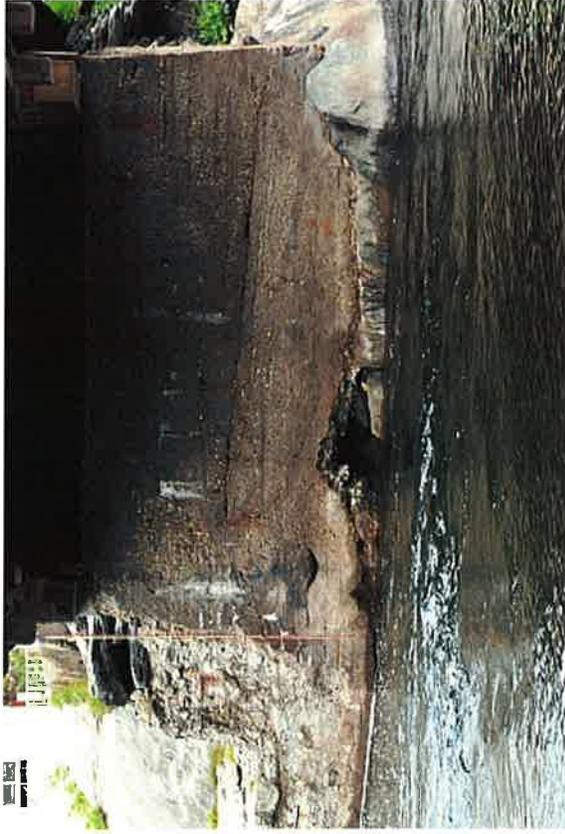
Scour hole at north abutment

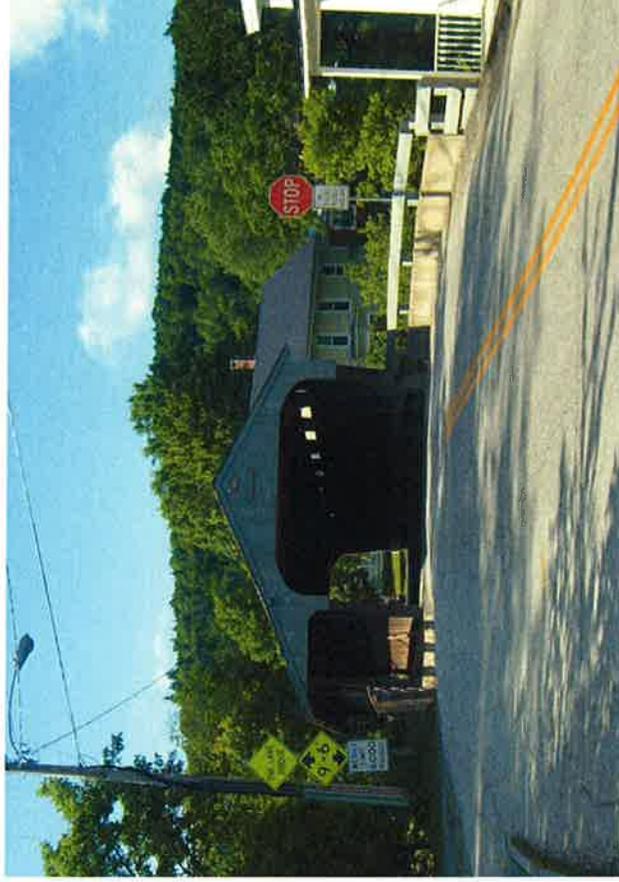
Signing on the north approach

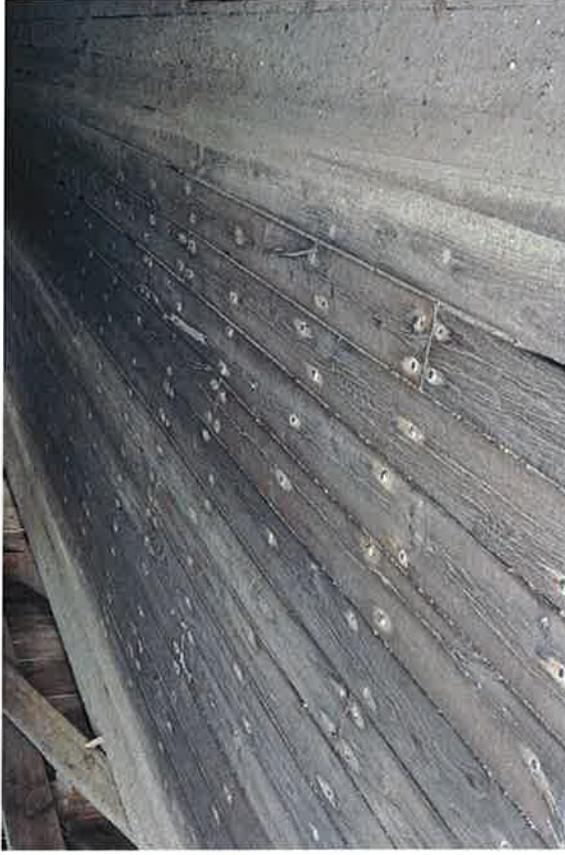
The condition of the timber deck planks in the main part of the bridge varies throughout its length, and approximately 50% need to be replaced. The middle 8-10 foot of width of planks throughout the length of the bridge is in poor condition, due to repeated exposure to traffic. These planks exhibit signs of wear (section loss), splitting and warping. However, the exterior 3-4 feet on both sides are in good condition. It would be most economical to replace only the middle 8-10 feet of planking; however, it may be difficult to match the thickness of the exterior 3-4 feet on either side if this approach were taken. Additionally, the exterior 3-4 feet may warp or split much sooner than the middle 8-10 feet if only the middle planks are replaced. Therefore, it is recommended that the entire 16 feet of planking be replaced throughout the length of the bridge.

Timber deck planks

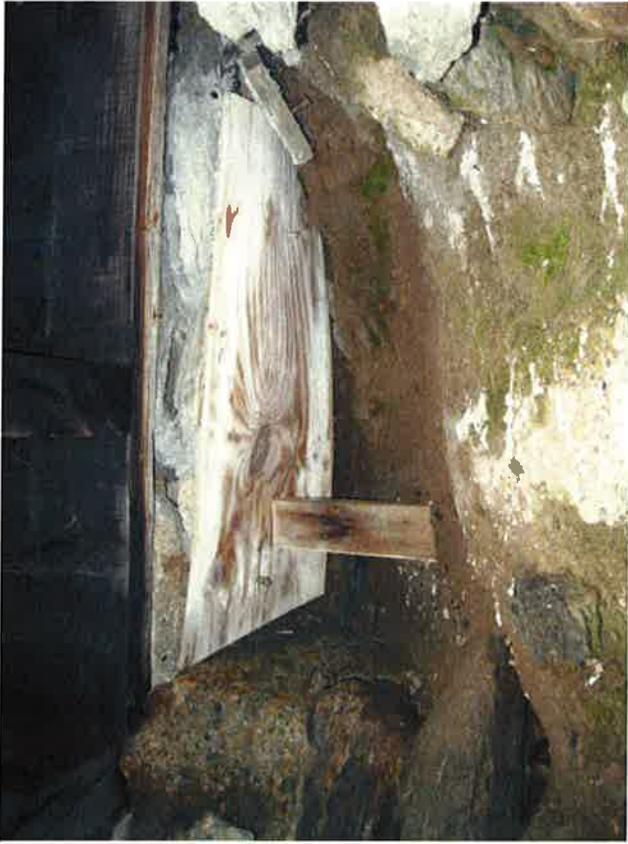
- Stone abutment sections in good condition, some missing chinking stones
- Approach signing cluttered and some signs out of plumb
- North sidewalk timber approach (bridge) and bearing is being undermined and has settled

Support for the sidewalk approach on northeast corner

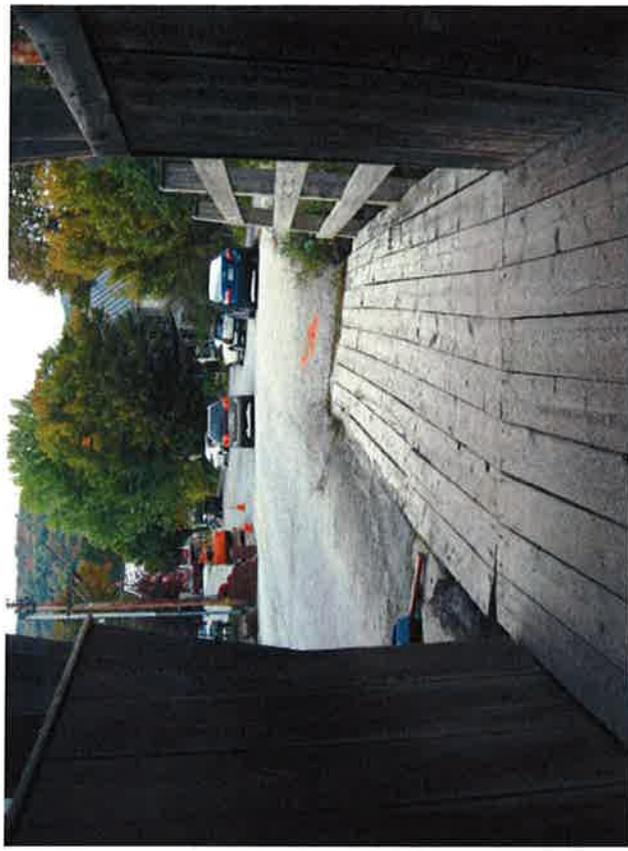
Sidewalk approach on the northeast corner

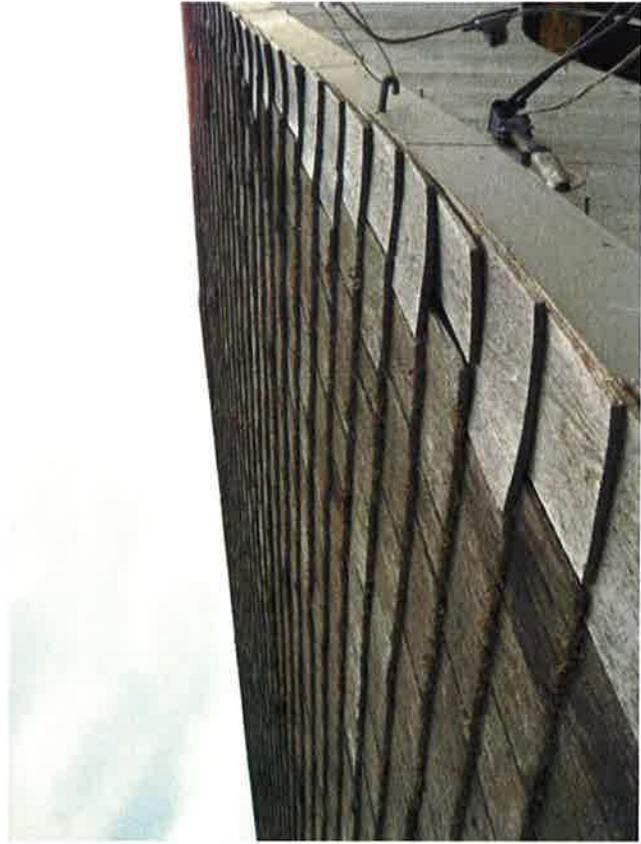
The existing cedar shingle roof is in good condition. There are several shingles that need to be replaced, but these are quite limited. We recommend only that any loose or split shingles be replaced. We do not recommend that the entire roof be replaced with a metal or other type of roof at this time. While a metal roof would be lighter than the shingles and would shed snow better, the existing roof is still in good condition and

Cedar shake roof in good condition

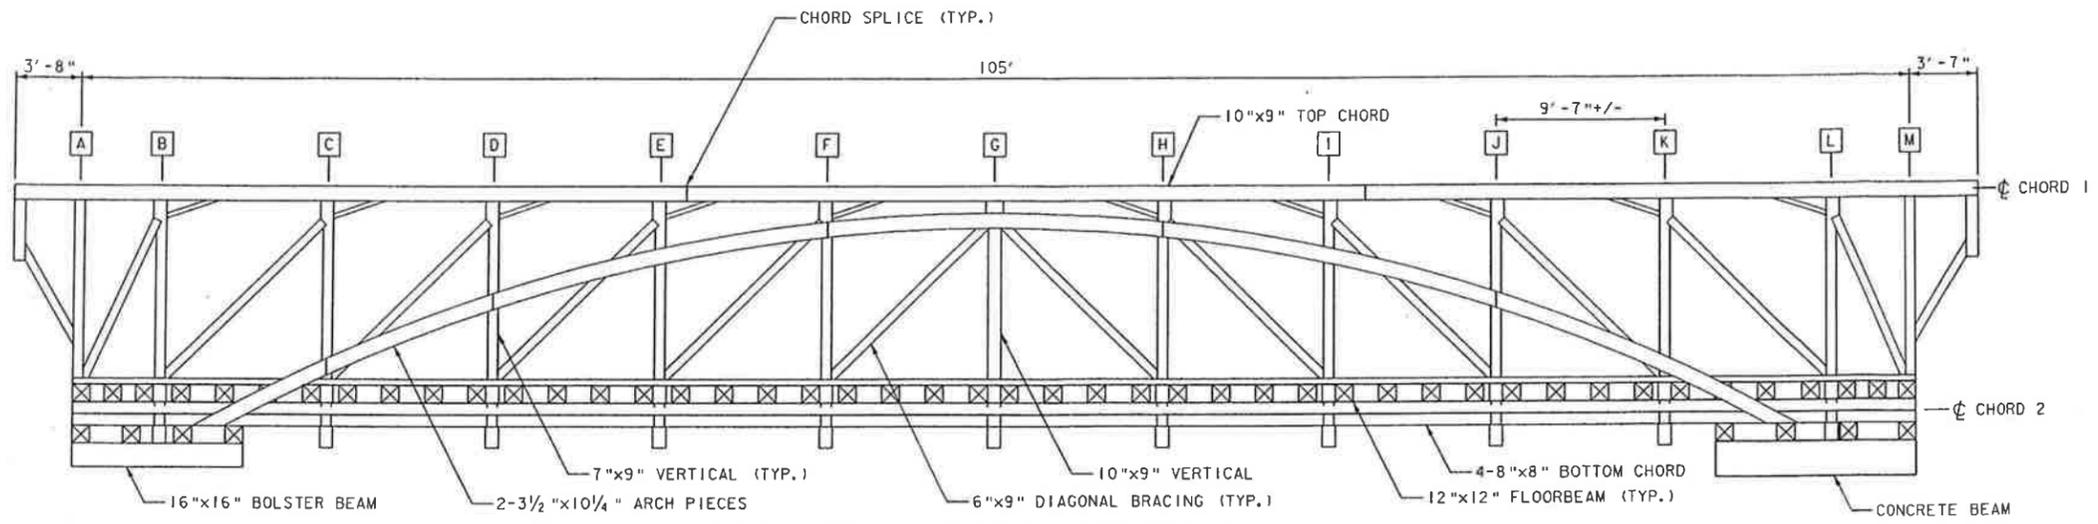
UPSTREAM TRUSS ELEVATION  
(LOOKING EAST)  
SCALE 1" = 5'-0"

- Upstream truss in fair condition, with downward deflection of up to 1 5/8". Some minor rot observed at the ends of the web members (compression members)

There are several inches of vertical deflection in each of the main trusses – as much as 1 5/8” in the upstream truss and 3 5/8” in the downstream truss. This is an undesirable condition and is a symptom of the age of the bridge. There are no rotten or broken members in the trusses; therefore it appears this condition is due to long term creep. The only way to repair this condition is to jack up the trusses and rebuild them. We recommend that this type of repair be considered for both trusses, depending on how they look after the cantilevered sidewalk is removed.

This repair would not involve the replacement of any of the existing truss elements. However, most truss members would be “lengthened” by the addition of wood shims at the end of each member. Once each truss is temporarily jacked so that there is no deflection, “gaps” would appear at the ends of the elements. These gaps would be filled with custom milled wood blocks that match the existing truss elements. Bolted and trundled connections would be reconstructed/replaced. Once the temporary jacking is removed, the trusses would no longer sag, and would have a zero (flat) or positive (upward) camber.

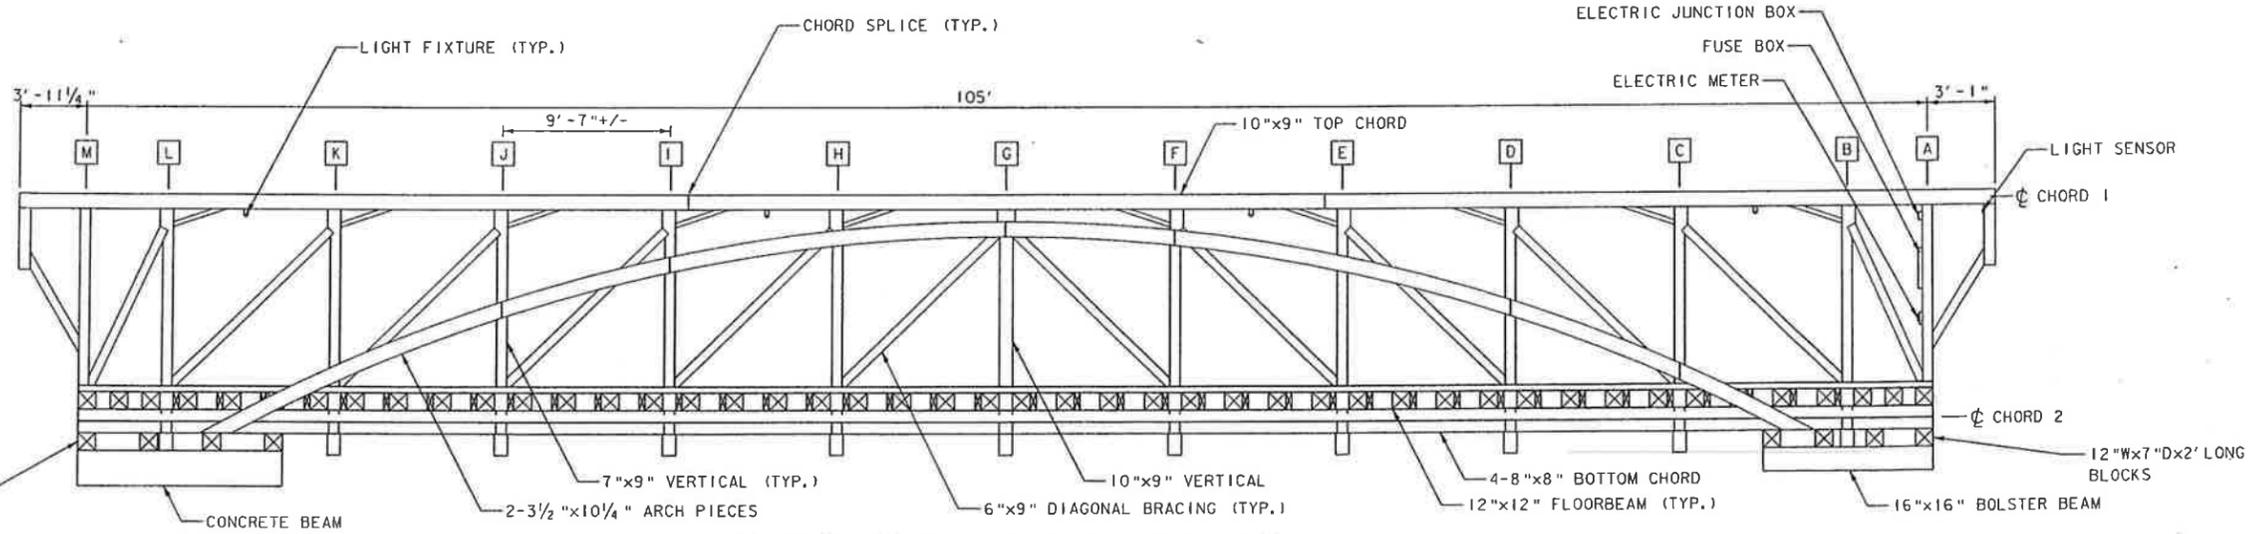
DOWNSTREAM TRUSS ELEVATION  
(LOOKING WEST)  
SCALE 1" = 5'-0"

- Downstream truss in poor condition, with excessive downward deflection (negative camber) of up to 3 5/8". Some minor rot observed at the ends of the web members (compression members)
