Wu Ledges Town Forest

Recreational Trails Inventory and Assessment

August 2013

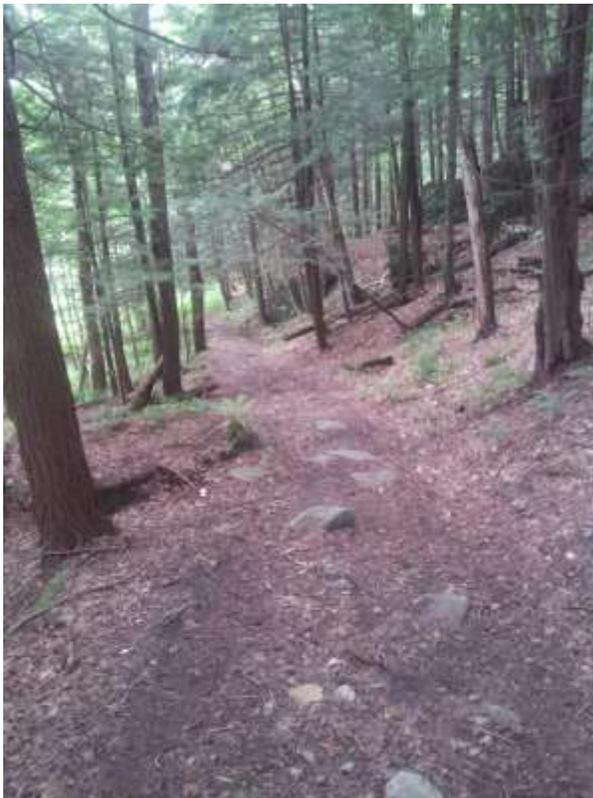
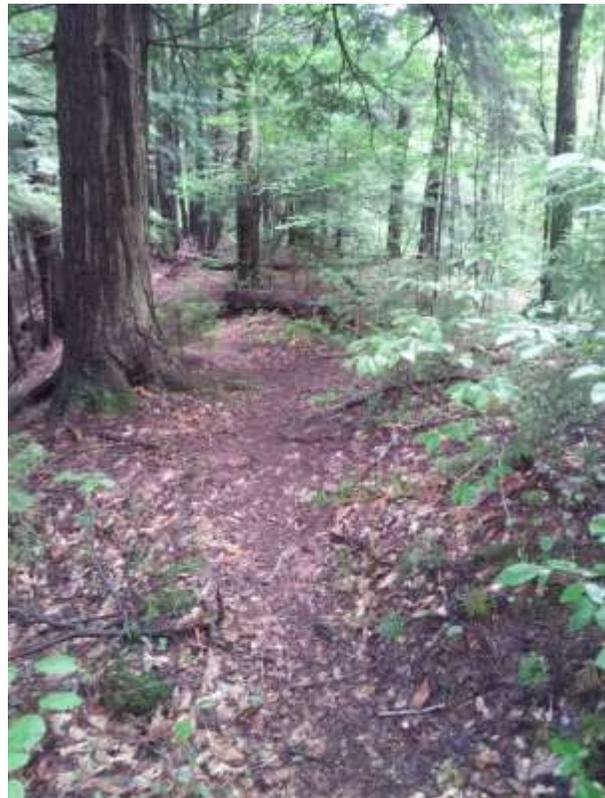
The majority of the trails throughout Wu Ledges have no signs of damage or deterioration and are suitable for mountain biking and hiking. In general, erosion was absent and drainage was sufficient, thus not posing a problem for recreational users. While trails varied in width, all were wide enough for both bikers and hikers.

Two trails representative of the overall trail condition at Wu Ledges

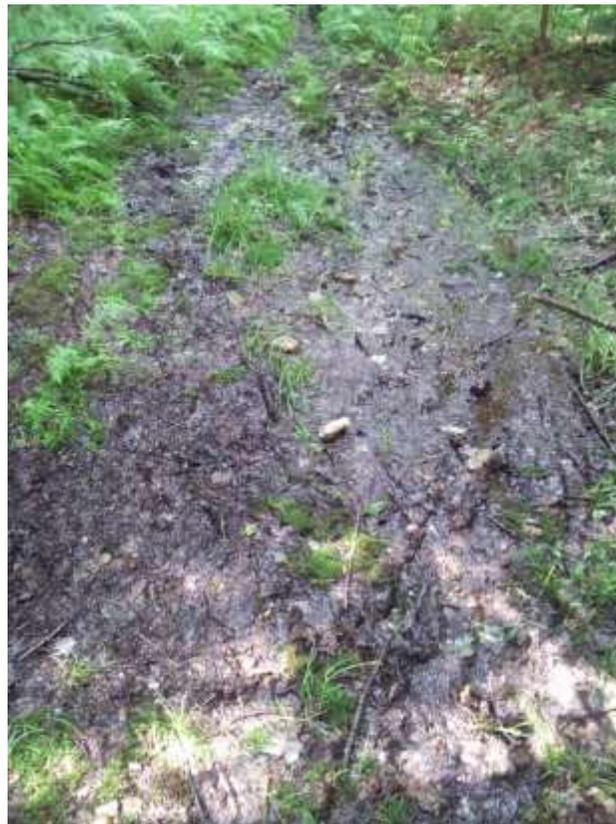
Poor drainage on trail

Though most of the trails are in good condition, it is important to monitor trails that may have the potential to become wet or eroded. As marked on the Points of Interest map on page 21, wet spots may be places where logs, boards, or other structures can be put in place to help curb the effects of poor drainage. Water bars are also a suitable structure that can prevent areas of the trail from pooling water in the first place.

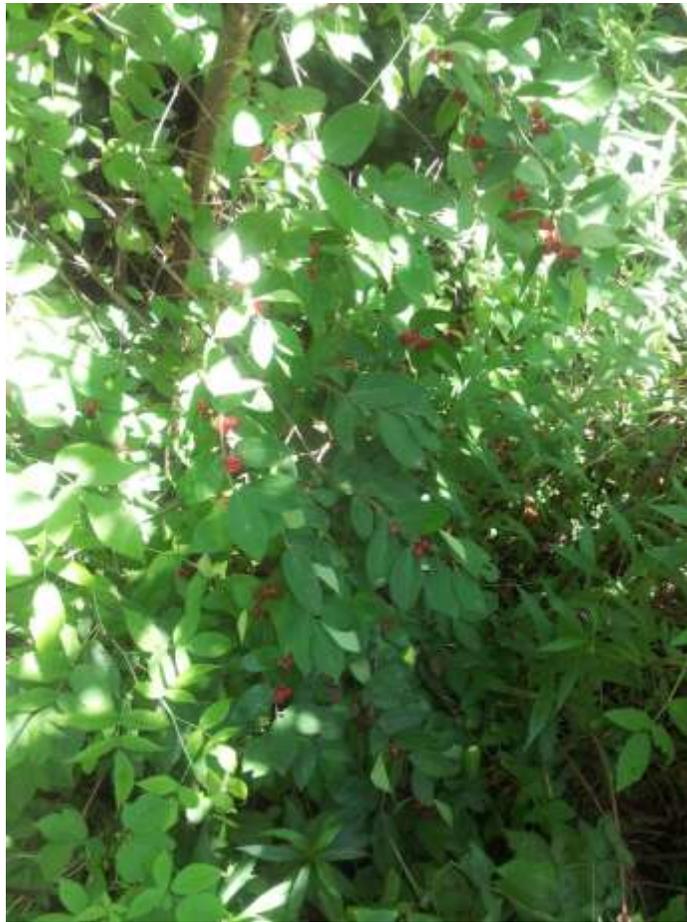
Trails are a possible vector for invasive plant species to enter the property. Monitoring of the access points to the property is an important step that can be taken to prevent spread of these species. As noted previously, patches of barberry were found just outside the southern border of the Lawton easement, and these populations can easily spread into the property via the trail. Honeysuckle was also found in large patches along a logging road (see map on page 21) that travels through the property. Though the honeysuckle is located outside the property, it is still possible to spread into the area.

Honeysuckle bush on logging road

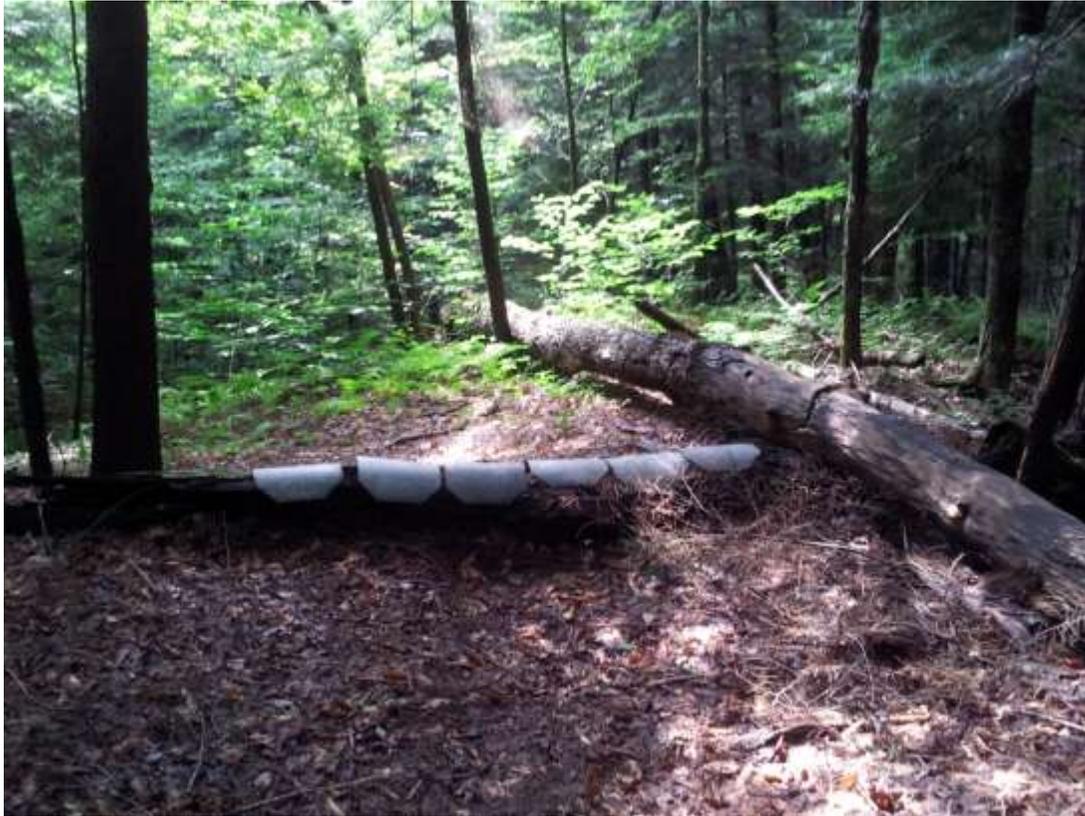
Current efforts to direct hikers and bikers onto the correct trail

Signage is something of major need within the property. Currently, there are only three signs for the Wu Ledges property: one is located on the trail from the Jamiesons, at the ledges, and the other on the eastern boundary of the Waitsfield easement. Signage is crucial to helping visitors understand where the property boundaries are and prevent them from entering private property. We recommend that signage also be placed on any trails that should be closed so that hikers and bikers will know which direction to follow. This will help at intersections that include trails leading out of the boundary, such as the intersection where there is barbed wire on the points of

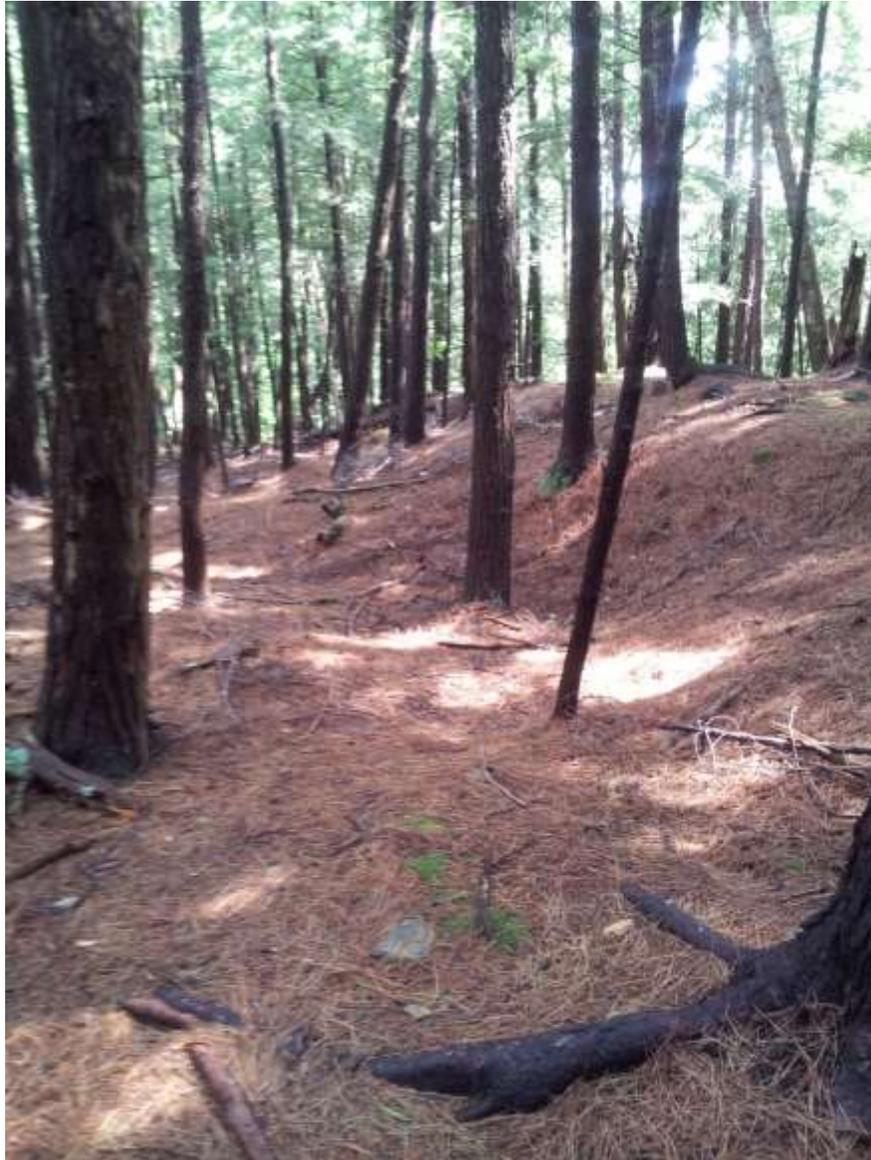
In areas dominated by hemlock trees, there is very little leaf cover and it is difficult to determine where the trail extends next. It is clear that in these areas, bikers have run into the same problem, considering there are shortcuts and bike tracks visible off the main trail. Signs or blazes would be extremely helpful in these areas so that only one trail is used, preventing extraneous damage to the surrounding ground cover. Additionally, in the case of an established mountain biking trail network, we recommend that signage informing hikers of mountain biking activity on the property be placed throughout the property for safety purposes.

Signage or blazes needed in these areas to determine where trail leads

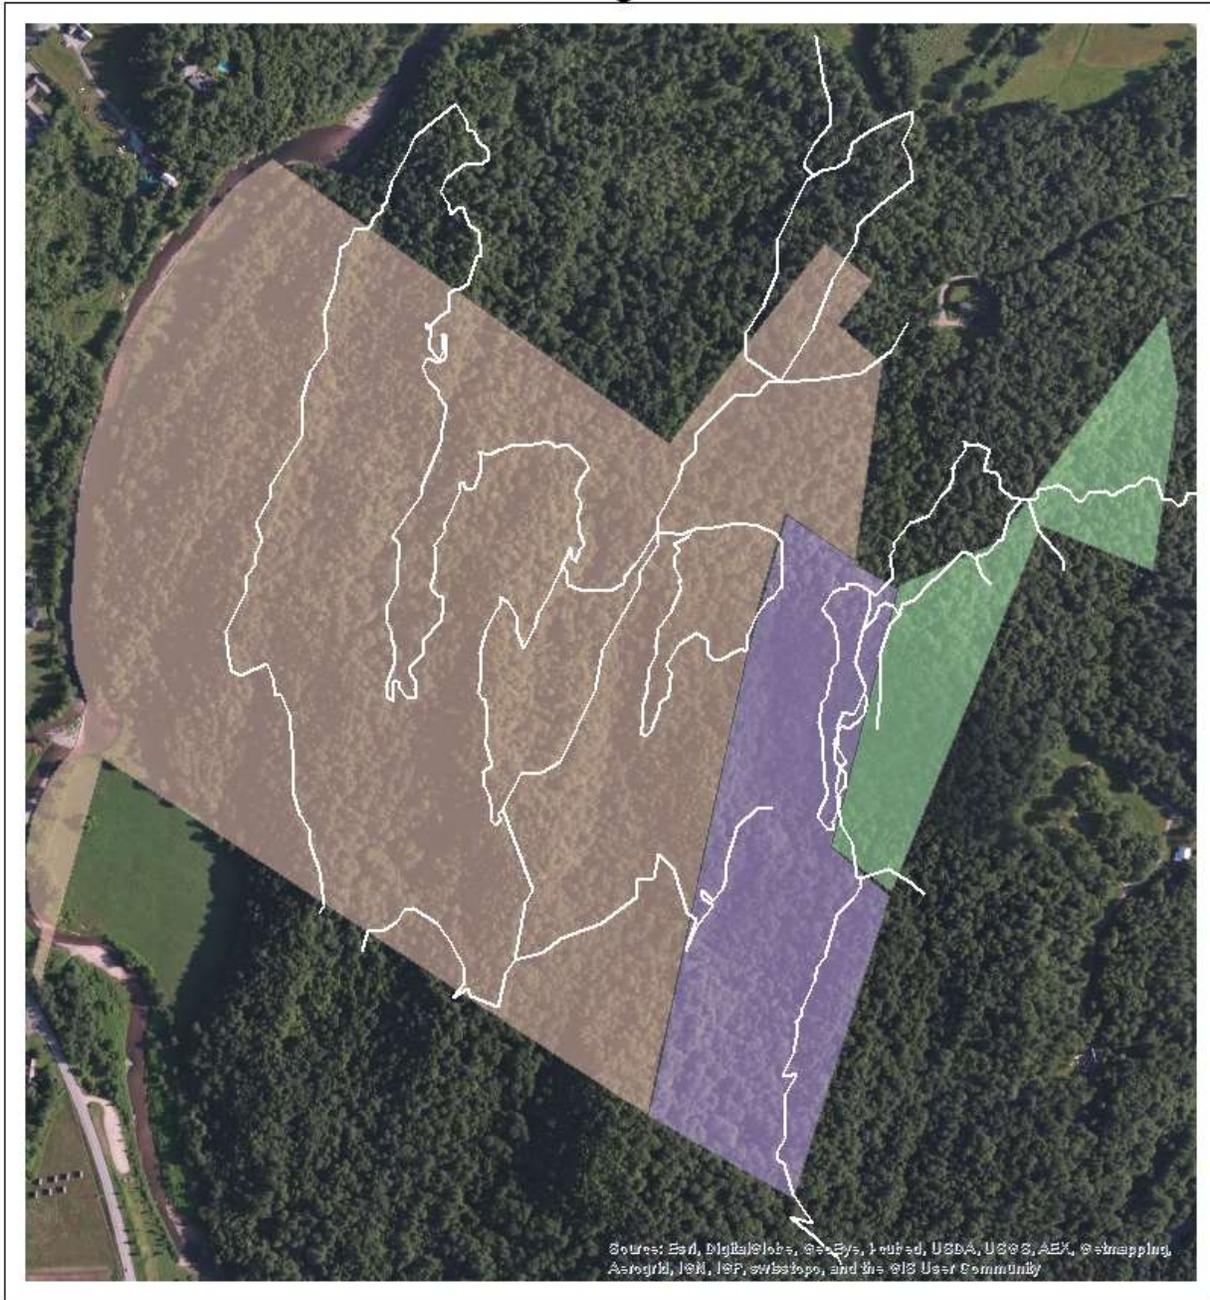
Wu Ledges Trails

All trails within Wu Ledges and the two adjacent easements were mapped. There is a complex network of trails on the property, most of which lead either to the Ledges themselves or into adjacent private land (see map on page 20). According to the 2012 Draft Town Plan, this may be because trails rights on adjacent land are also under easement. While this may be legal, public access points to the property remain limited, unmarked, and inaccessible for both hikers and bikers not living on surrounding property. Most users are entering on established paths through private property that connect to the main trail leading to the Ledges. In particular, visitors appear to be parking on Bridge Street in Waitsfield and walking up through the cemetery to access Wu Ledges. Other primary users appear to be nearby residents for whom public access points do not matter.

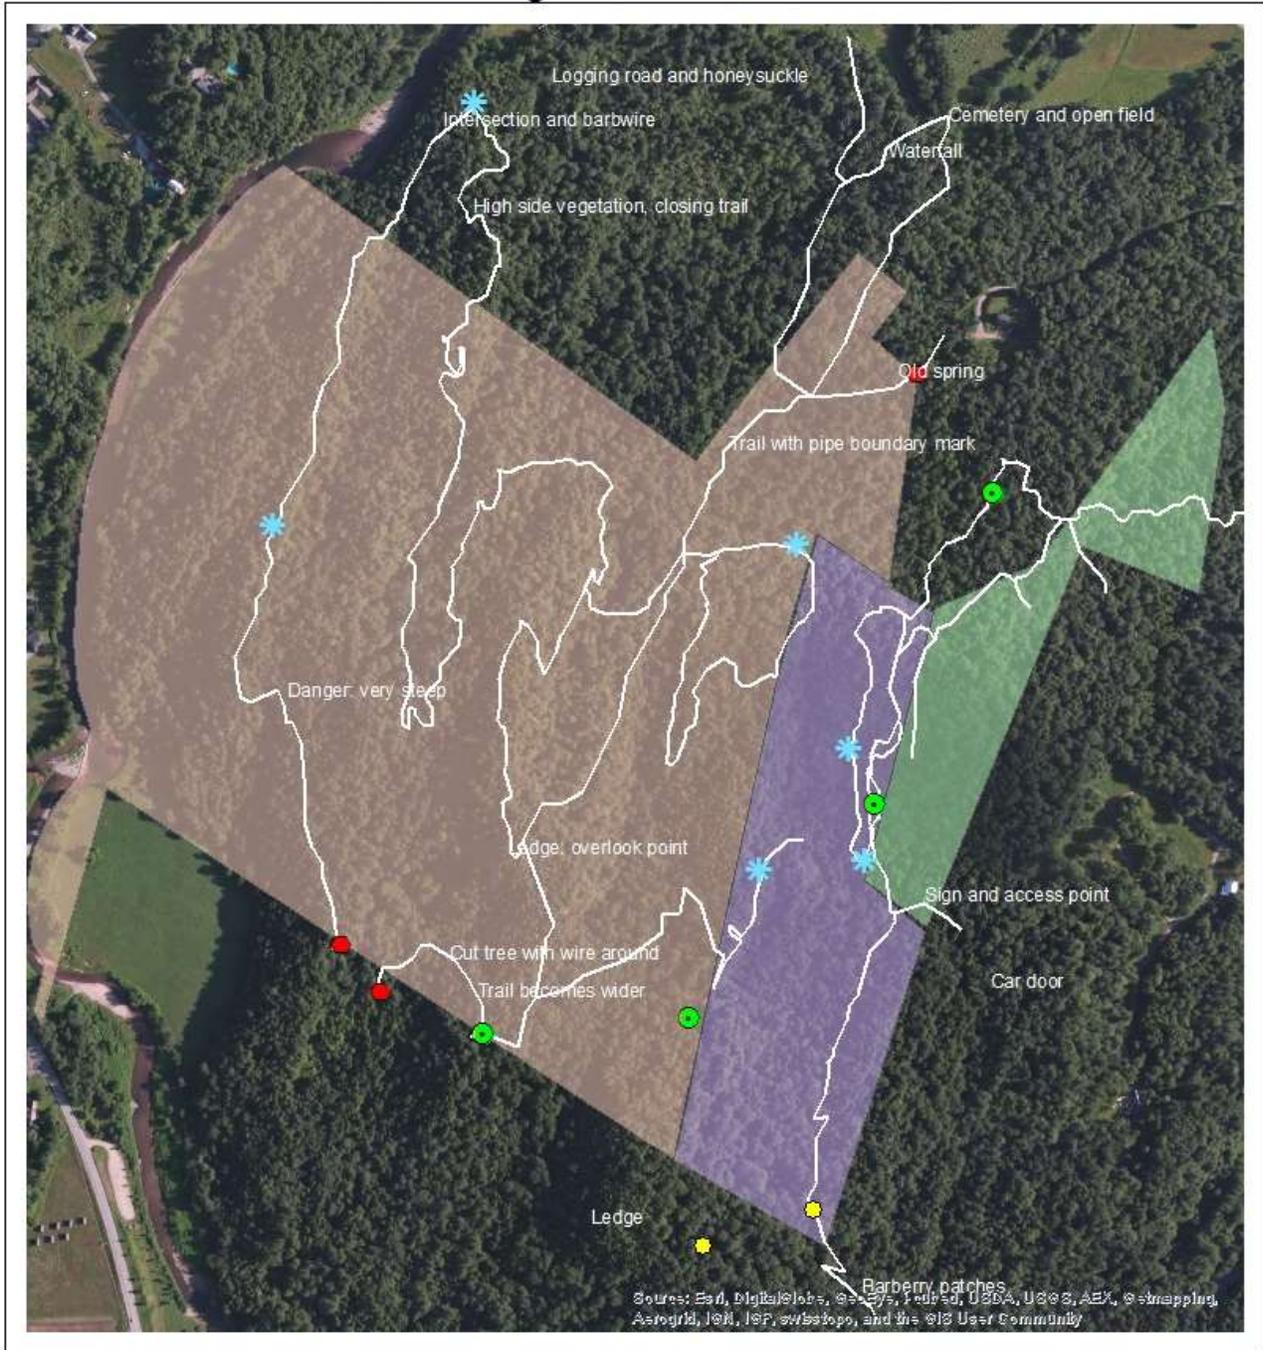
Wu Ledges Points of Interest

Several short sections of trails were overgrown with shrubs or ferns, particularly in the northwest and northeast corners of the Ledges, providing evidence of their limited use. Only periodically were there wet spots of concern, fallen logs, or evidence of human use found, as noted on the map on page 21. Trails throughout the conifer-dominated areas that have sandy, acidic Berkshire series soils were the most difficult to follow because of the lack of understory that grows in such shaded conditions. They are also much more soft than trails in the Northern Hardwood area of Wu Ledges and could be more susceptible to erosion should a proper mountain biking trail system be established.
